Release Notes for the Catalyst 3750, 3560, 2970, and 2960 Switches, Cisco IOS Release 12.2(37)SE and Later

Cisco IOS Releases 12.2(37)SE and later run on all Catalyst 3750, 3560, 2970, and 2960 switches and on Cisco EtherSwitch service modules.

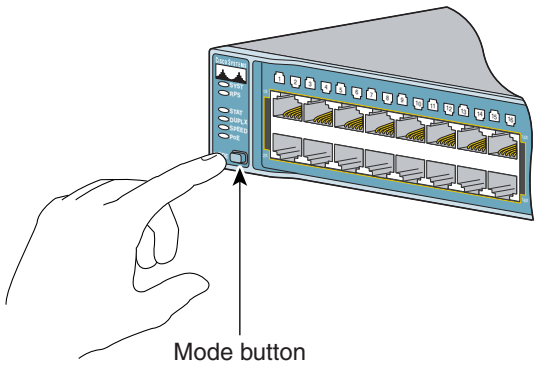
| Step 5 | <p>Press and hold the Mode button for 3 seconds. When all of the LEDs left of the Mode button turn green, release the Mode button.</p> <p>If the LEDs left of the Mode button begin to blink after you press the button, release it. Blinking LEDs mean that the switch has already been configured and cannot go into Express Setup mode. For more information, see the “Resetting the Switch” section.</p> | <p>Mode button</p> |

| Step 6 | <p>Verify that the switch is in Express Setup mode by confirming that all LEDs left of the Mode button are green. (On some models, the RPS and PoE LEDs remain off.)</p> | |
